# Report on Archaeological Investigations

Berry Close,  
Chacombe,  
Northamptonshire

HER Event UID: ENN109262

Prepared by Stephen Wass MA, MCifA  
For  
Berry Close Charitable Trust

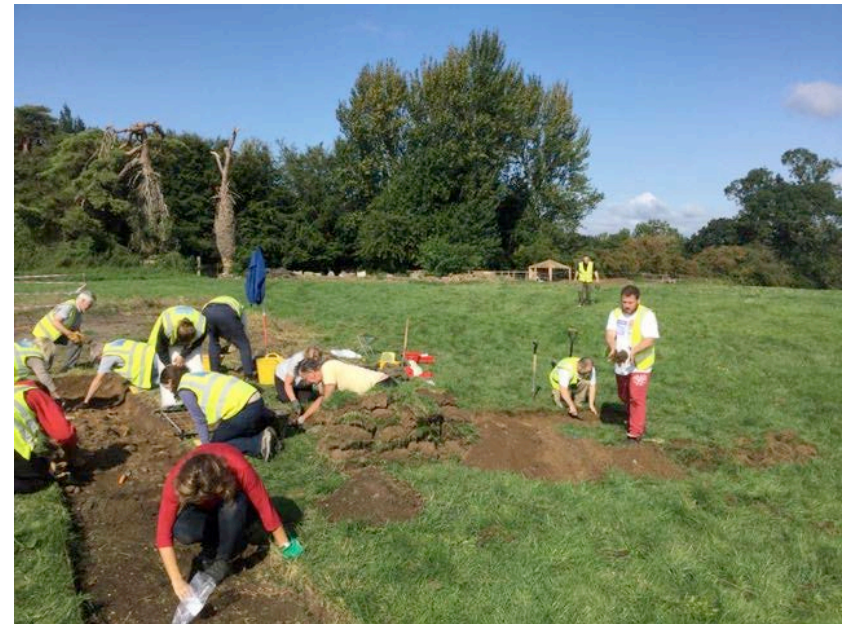
Fig. 1 Trench C looking north west, Saturday August 25<sup>th</sup>.

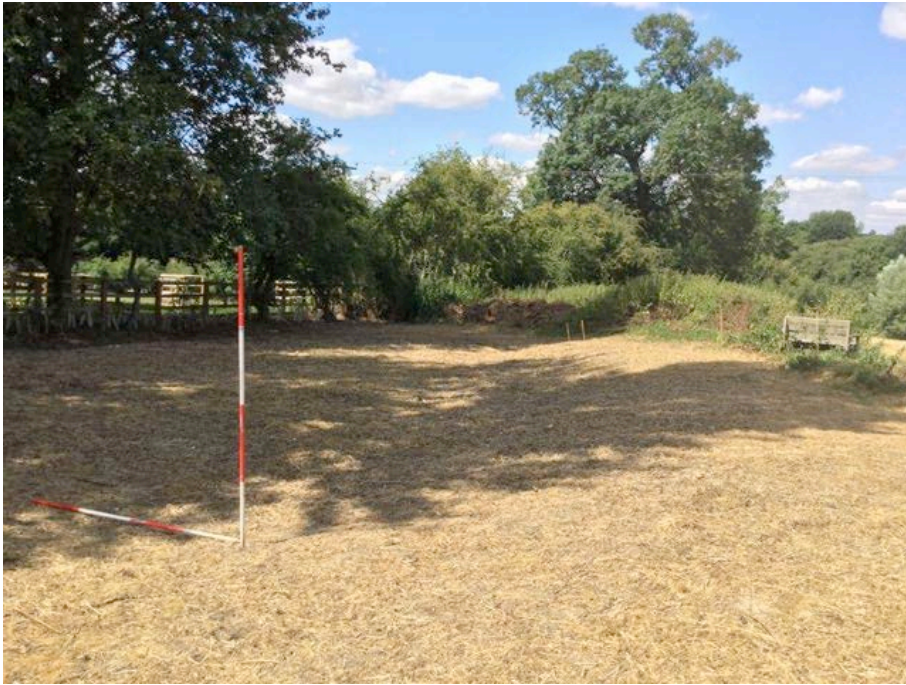
Fig. 5 Bank and ditch, view looking north across evaluation area

4.1.1 Site Clearance and earthwork survey. The site had already been cleared of undergrowth (Fig. 5) enabling a detailed contoured earthwork survey to take place whilst the excavation was getting underway (Fig. 6). A metal detector survey was also undertaken across the area. The survey demonstrated the presence of a low broad bank running north north west and curving round slightly further to the west. The ground to the west of the bank was significantly lower by around 0.5m and there were traces of a shallow ditch at the foot of the bank.

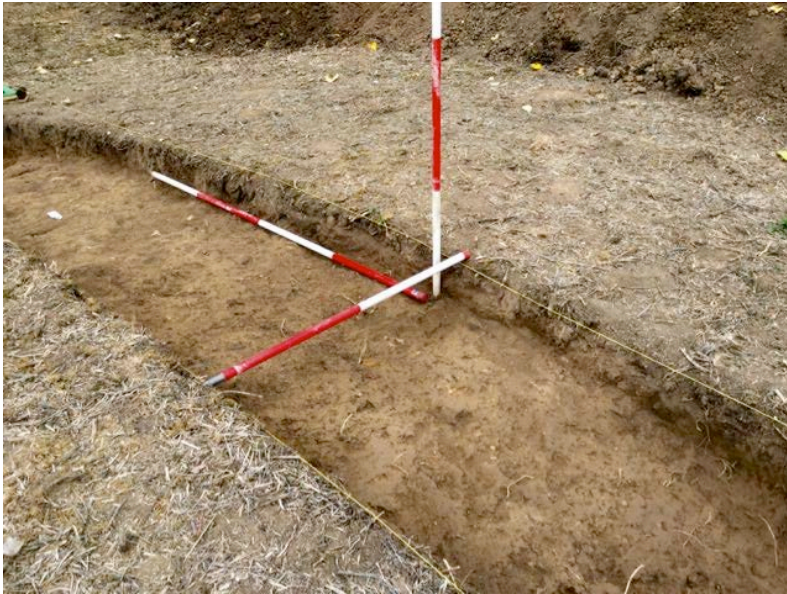
Fig 8 Crest of bank 012 view looking north west.

4.1.2 Excavation. Immediately below the shallow topsoil (001) was the crest of a broad shallow clay bank (Fig. 8). To the east this had been cut into by a shallow 'V' shaped ditch (013) with a darker loamy fill (007) containing a few scattered pieces of rubble (Fig. 9). Further east beyond the ditch was a deposit of clay (003) which lay upon a clayey subsoil (004). The deposit may be upcast from a cut further east beyond the trench end. A shallow flat bottomed ditch (011) lay at the foot of the

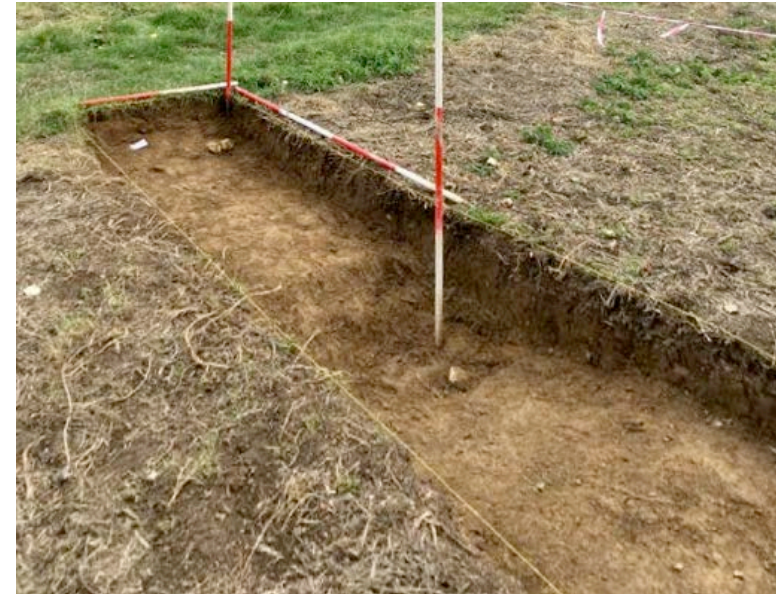
Fig. 9 Ditch 013 and fill 007 looking south east

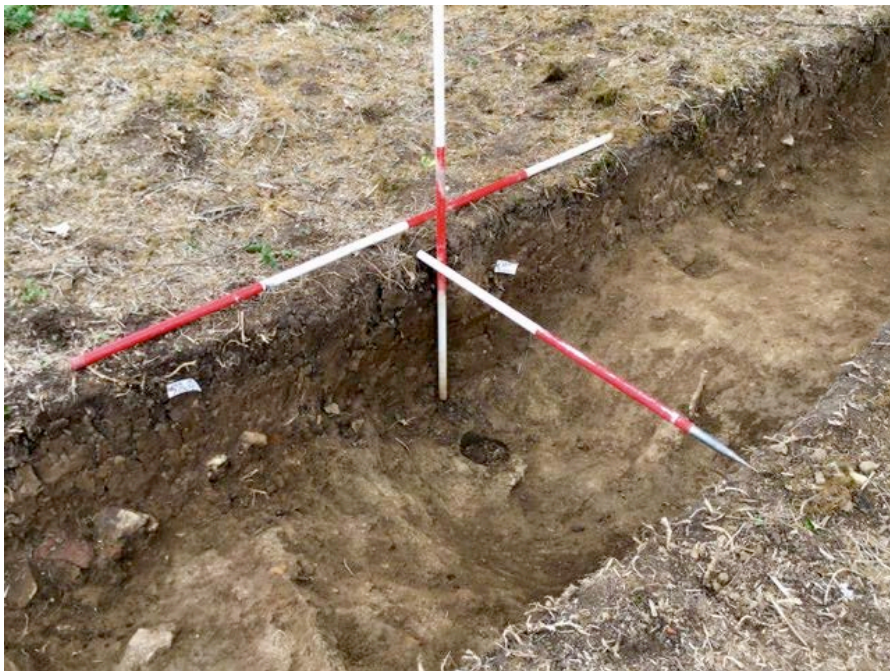
Fig. 10 Ditch 011 after removal of fill 014

bank to the west (Fig. 10). The upper portion of the fill was a darker loam (014) and this lay over a more mixed deposit (005) which combined silting and material eroded down from the bank. There was some difficulty differentiating these features as deposition and erosion had caused considerable intermingling of the layers. Within the ditch a modern treated timber fence post (006) had been inserted into a bored hole (016) and subsequently had been sawn off flush with the ground. Further west was a layer of natural looking mixed clay with some rubble (009) which had been cut into by a second ditch (010) filled with a clayey loam with rubble (008). Excavators made a deep cut into the bank to reveal an underlying layer of clean natural yellowish clay (015)

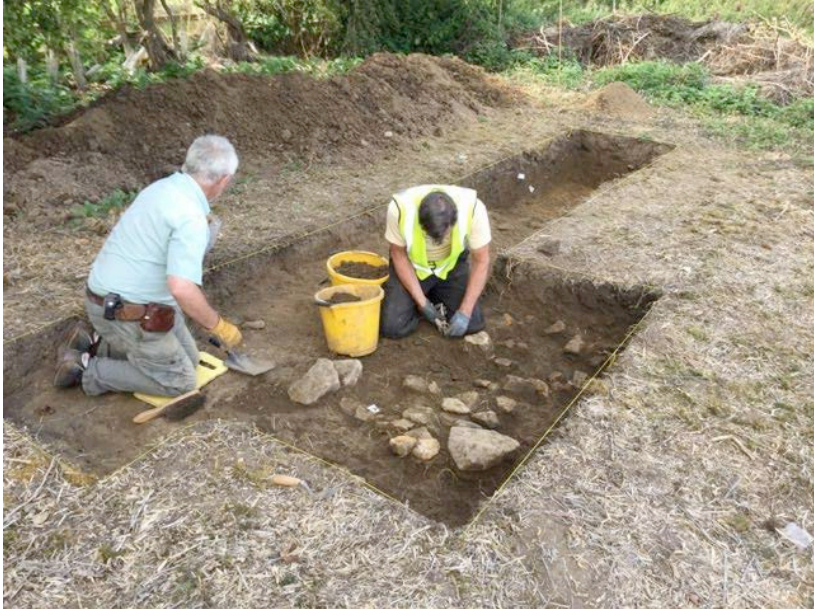
Fig. 11 Area B under excavation looking north west

4.2.1 Excavation. This area was opened up to examine the possibility of structures existing beyond the boundary bank which was curving round to the west past the north end of the trench. A thin dry layer of topsoil and parched vegetation lay above a deep deposit of silty loam subsoil. This sealed a cut (003) in the underlying natural clay (006) which was filled with a soft mix of dark clayey silt (004). A deposit of scattered rubble (005) was investigated by extending a section of the trench by a further metre to the east but there was no structure or depth to the feature and it probably represents odd stones cleared during cultivation.

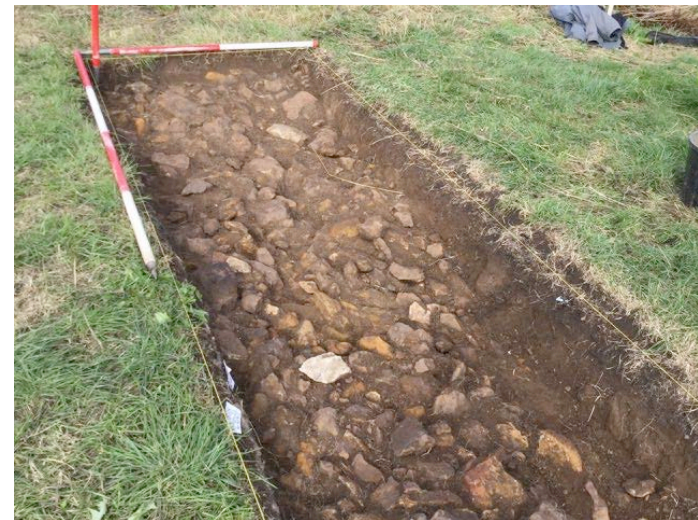
Fig. 13 Area C western part showing surface of rubble spread 004 looking east

**4.3.2 Excavation.** Initially a trench 4m x 1m running east to west was marked out but this was then extended by a further 5m to the east. A second trench was dug, at right angles to the north side, for 4m and then extended by a further 2m. Below a thin covering of turf and topsoil (001) packed rubble (004/005) spread across almost the whole area (Fig. 13).

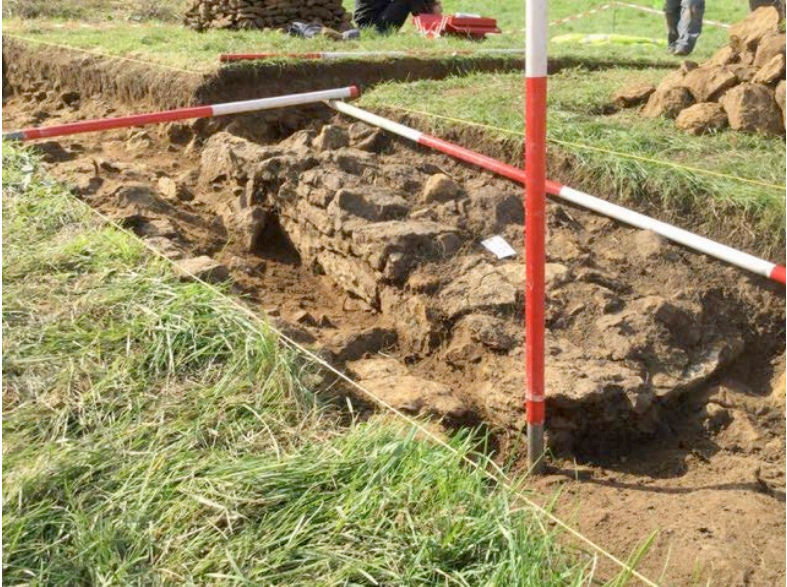
Fig. 14 Wall 009 looking north west

The upper layers of the rubble spread 004/005 were removed from the whole area except for the northern most 3m of the northern extension. Close to the centre of the trench this process uncovered the remains of a crudely built stone wall (Fig. 14) of 4 or 5 courses (009) partly founded on lower deposits of destruction material (010) suggesting a post-medieval date for this structure presumably associated with some agricultural use, possibly animal penning. At the east end of the trench a similarly roughly built wall was excavated (Fig. 18) only surviving as a single course (014) founded on compact clay and rubble (015) which may be natural. North of the centre and at a significantly greater depth the remains of a rather well built wall (012) were encountered (Fig. 17). This again was seen primarily as a single course but built of larger more regularly shaped blocks. Although no direct dating evidence was recorded for this structure it seems likely that this could be part of the remains of a building associated with the medieval manorial complex. Given the way it terminates within the trench it was suggested that we might be looking at the eastern side of an opening for a doorway. It is perhaps significant that beyond this opening to the north was what appeared to be the shattered remains of a paved area (011) laid out on a bank of mixed clayey loam (013). Where an area of 004 had been

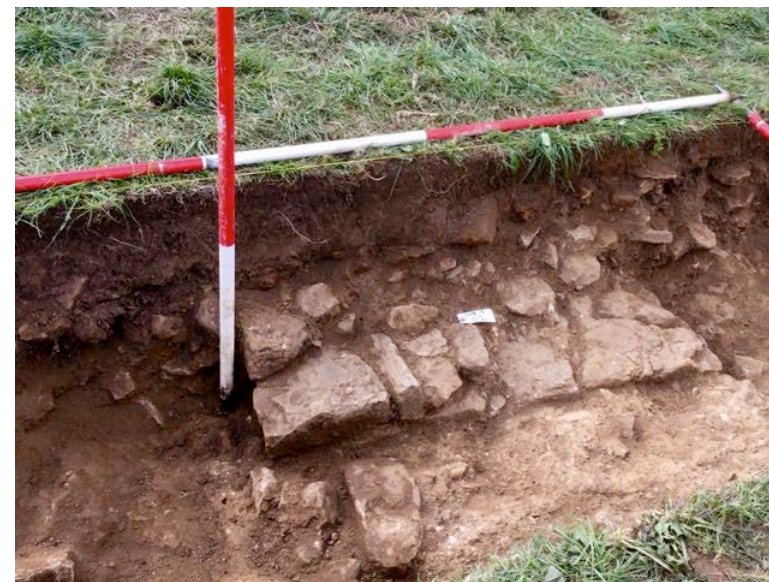
Fig. 17 Wall 012 looking west

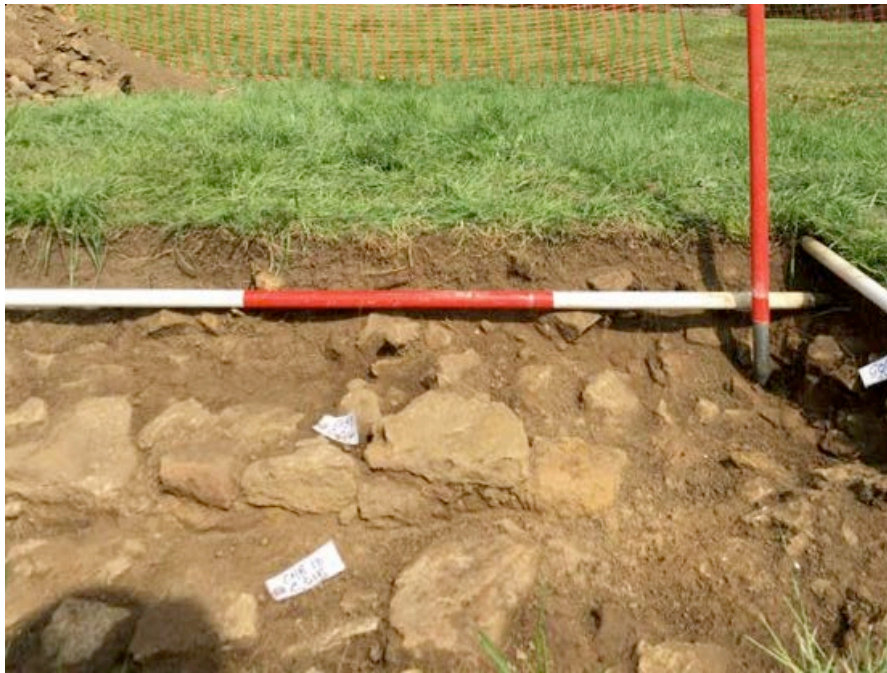
Fig. 18 Wall 014 looking north

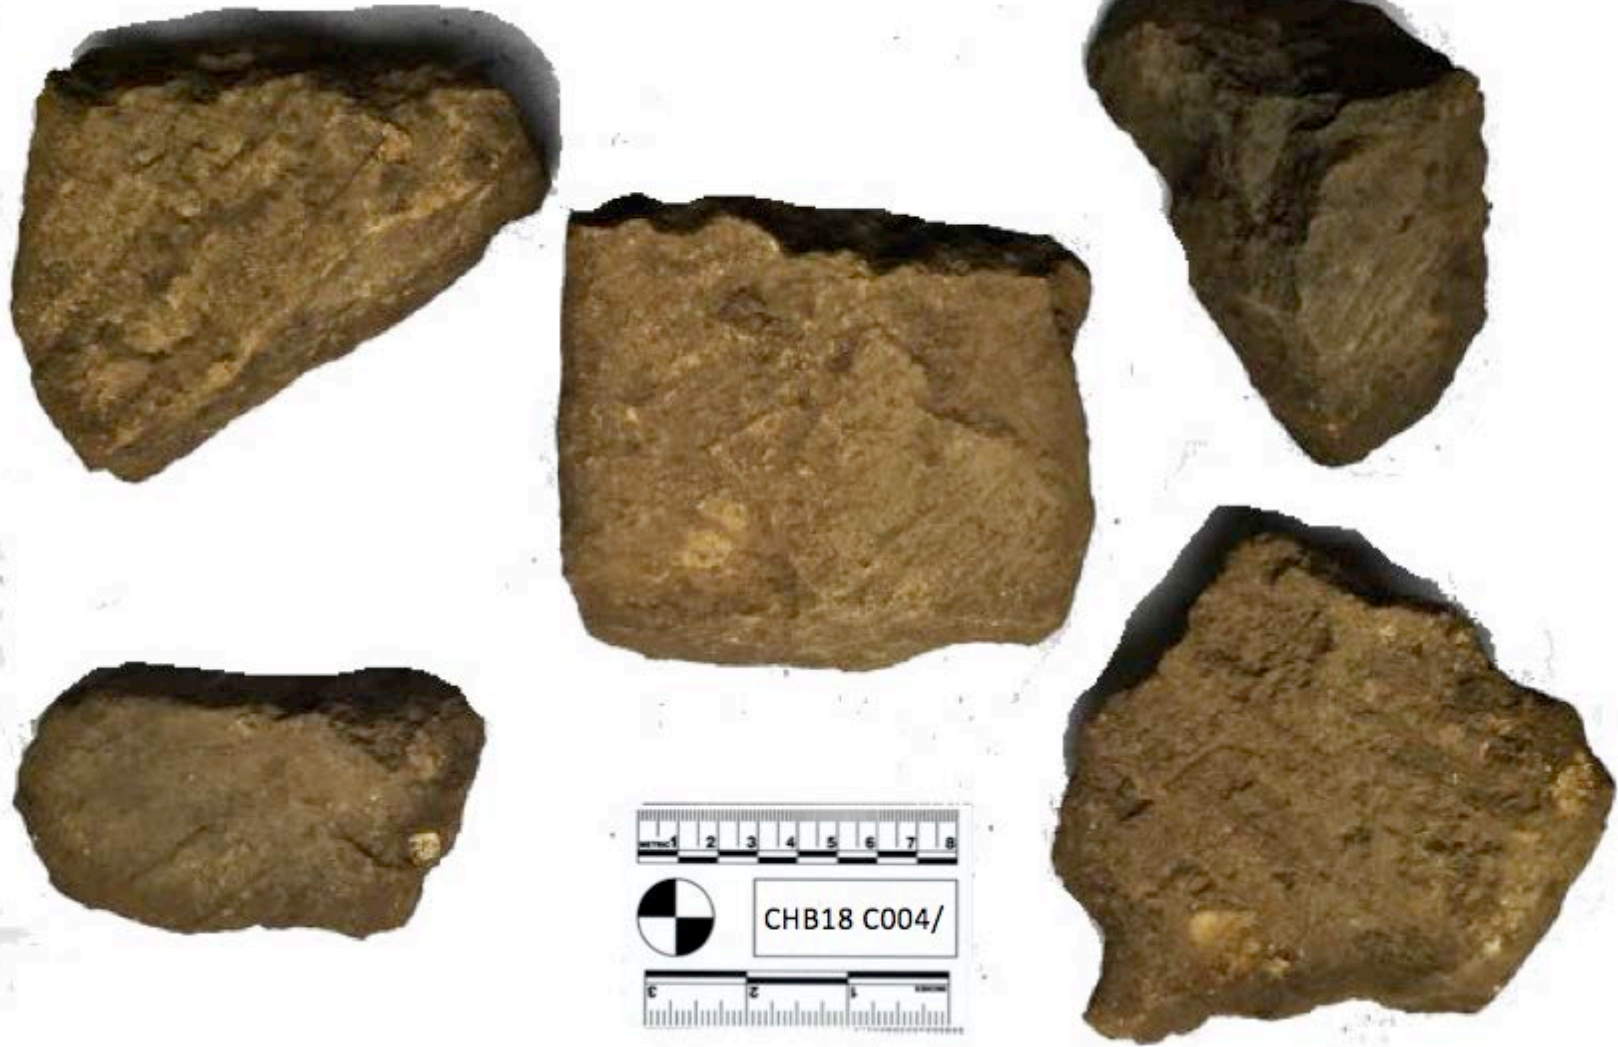
Fig. 33 C004 Dressed stone

A couple of early hand made iron nails were found together with some modern iron nails, overspill from the bonfire. A single piece of clay pipe stem, a wafer thin copper alloy disc, a few fragments of roof tile and some undifferentiated animal bones were also recovered. The key find was a very worn silver farthing of Edward III (002/2) (Fig. 37). In addition another very worn coin, this time a penny of 1921 (002/1) was discovered. This had been clipped to give it a slightly polygonal outline suggesting it had been modified for some other purpose, perhaps as a spacer in something mechanical. Although the vast majority of the stone lifted from 004 was rubble a few pieces of carefully dressed stone were identified again indicating the presence of a high status building (Fig. 33).

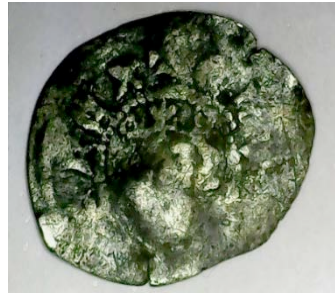
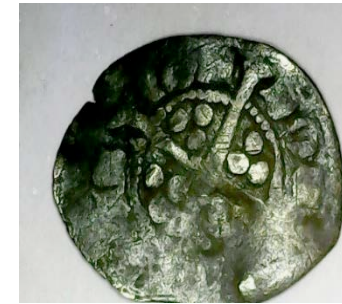
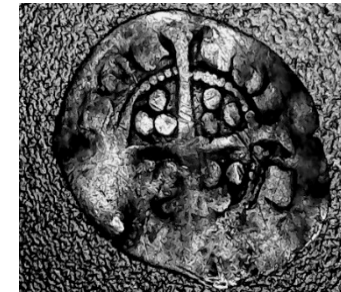
Type: farthing,  
Metal: silver,  
Circa: 1344 – 51,  
Weight: >0.2g  
Max length: 13.28mm.  
Max width: 10.49mm.  
Thickness: >0.25mm.  
Obverse: crowned portrait facing EDWARDVS REX after which there can be seen an edge of a mintmark; cross 3 (class g).  
Reverse: long cross with three pellets in each angle surrounded by the mint name CIVI TAS LON DON an indication that the coin was made by Tower Mint London.

Fig. 37 C002/2 Silver farthing
